Fukushima: Status for en igangværende ulykke

Lauritzen, Bent; Nonbøl, Erik

Bent Lauritzen og Erik Nonbøl

Risø DTU

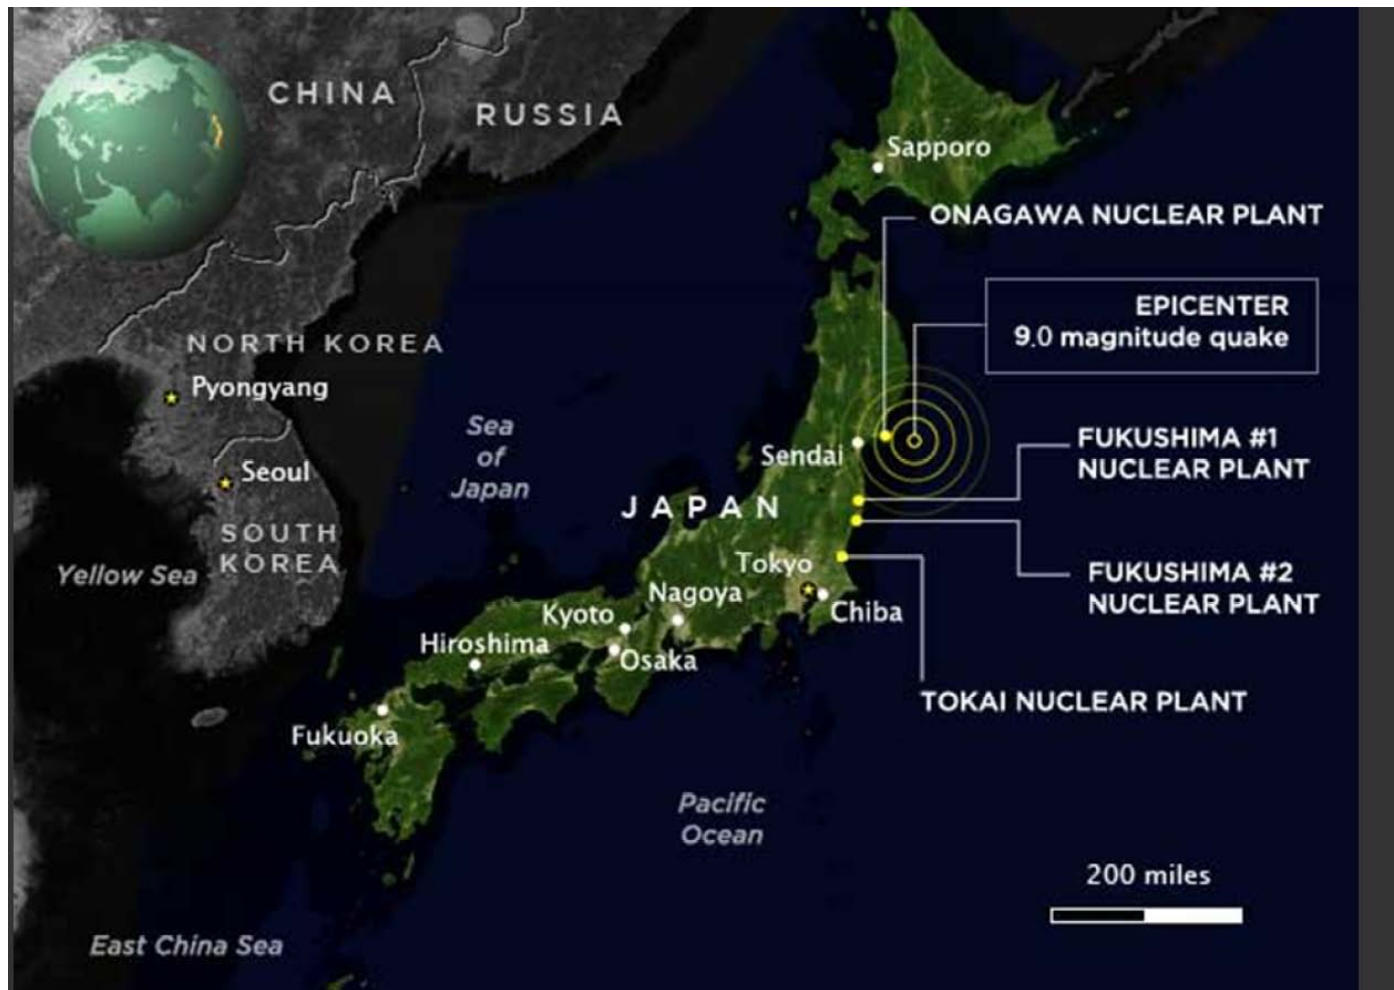
Japanske reaktorer tæt på epicentret

11. marts, lokal tid 14:46, gmt 06:46

1-3. Nuclear reactors near epicenter of the earthquake

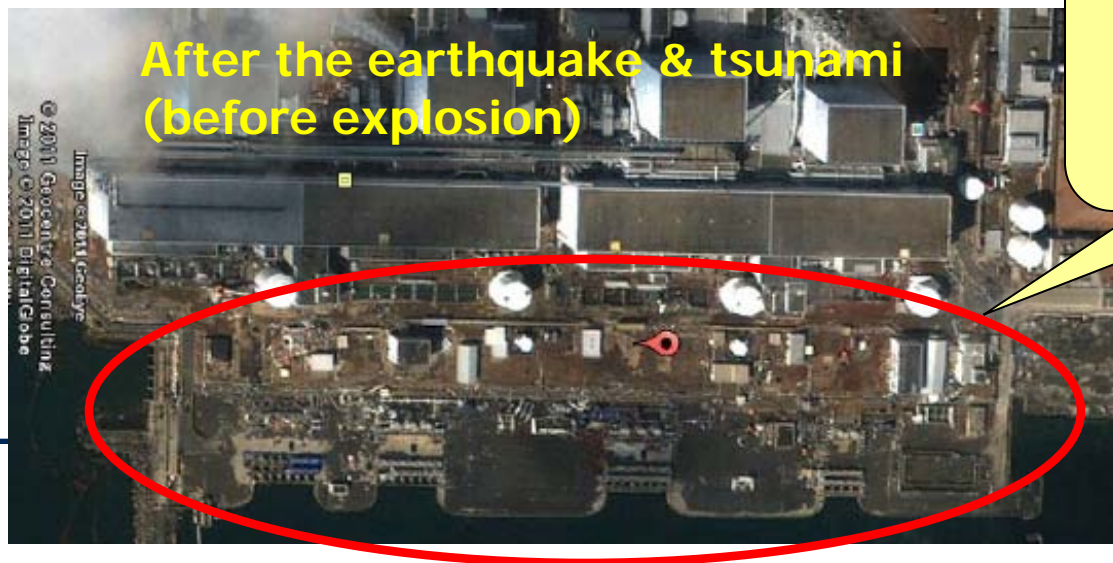
Fukushima 1 (Dai-ichi) NPP

Many
structures
facing the bay
are destroyed

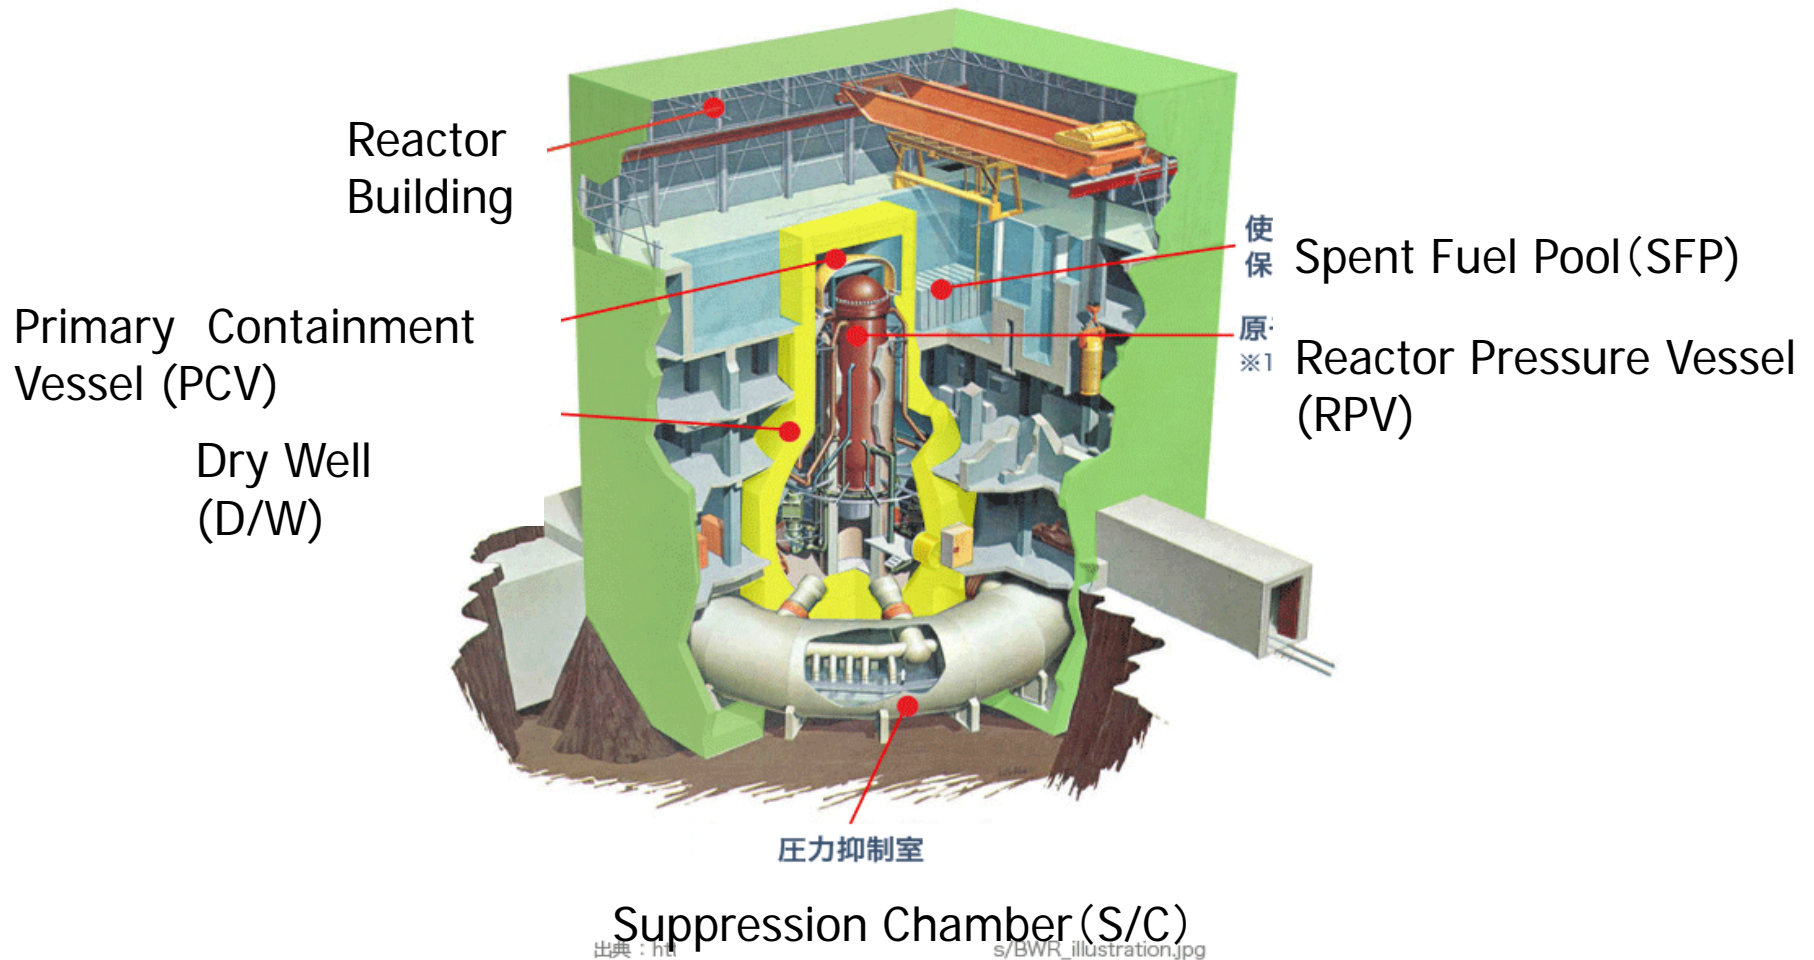
Overview of Mark-1 Type BWR (Units 1,2,3 and 4)

Unit	1	2	3	4	5	6
Number of Fuel Assembly in the Core	400	548	548	-	548	764
Number of Spent Fuel Assembly in the Spent Fuel Pool	292	587	514	1,331	946	876
Number of New Fuel Assembly in the Spent Fuel Pool	100	28	52	204	48	64
Water Volume (m ³)	1,020	1,425	1,425	1,425	1,425	1,497

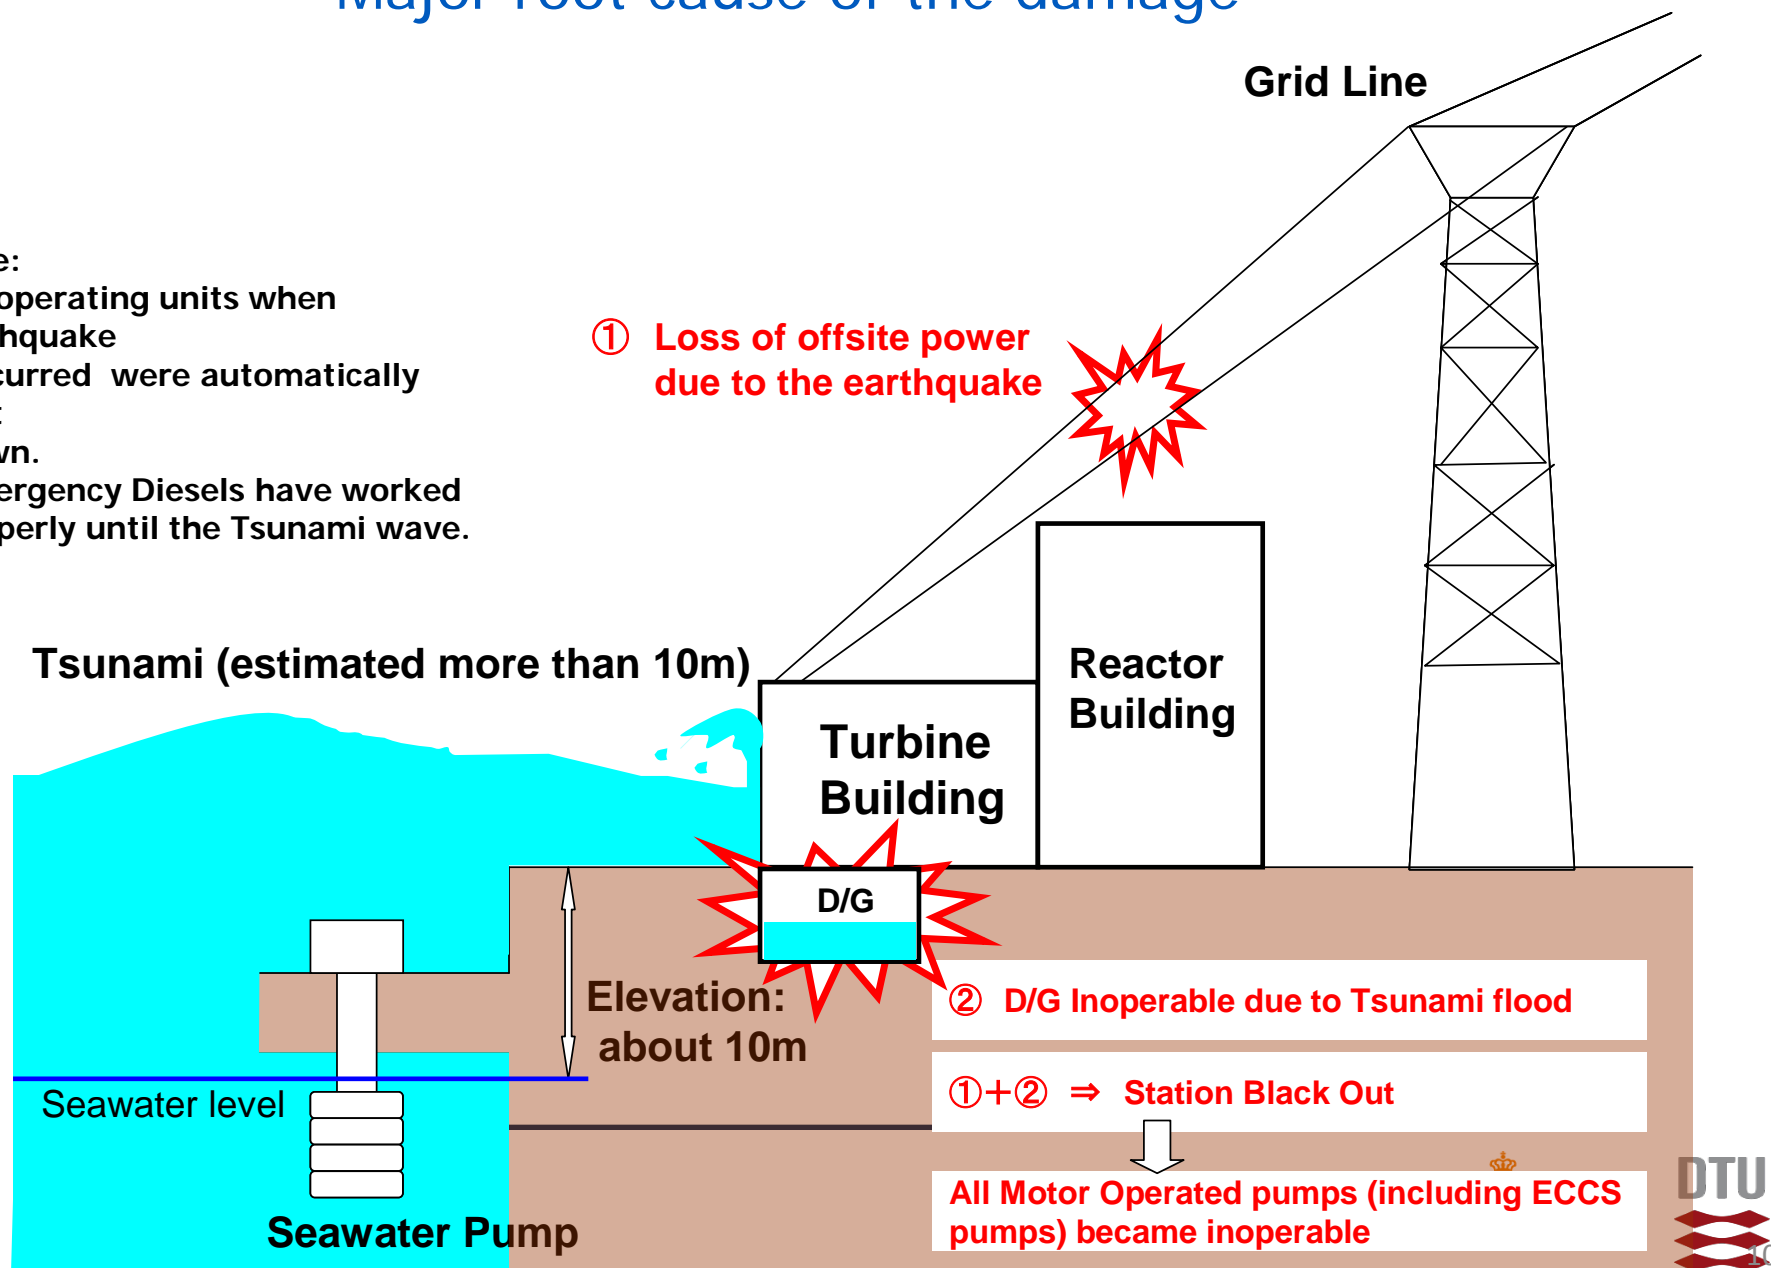
Major root cause of the damage

- All operating units when earthquake occurred were automatically shut down.
- Emergency Diesels have worked properly until the Tsunami wave.

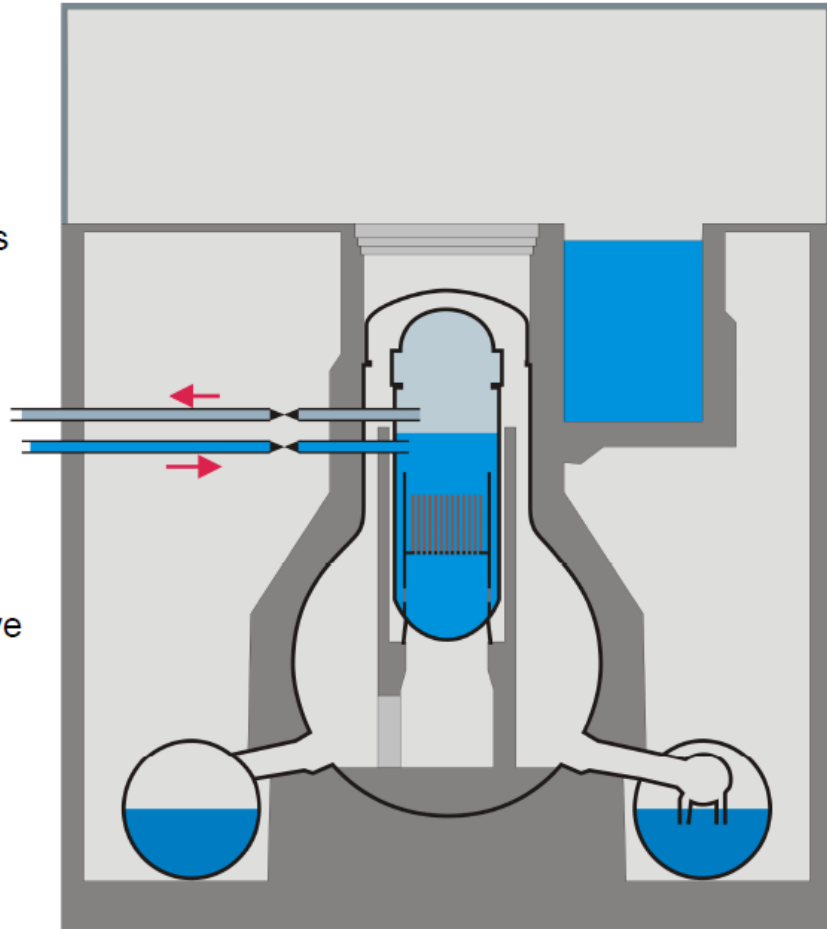
► 11.3.2011 14:46 - Earthquake

- ◆ Magnitude 9
- ◆ Power grid in northern Japan fails
- ◆ Reactors itself are mainly undamaged

► Automatic SCRAM

- ◆ Power generation due to fission stopped
- ◆ Heat generation due to radioactive decay of fission products
 - After SCRAM ~6%
 - After 1 Day ~1%
 - After 5 Days ~0.5%

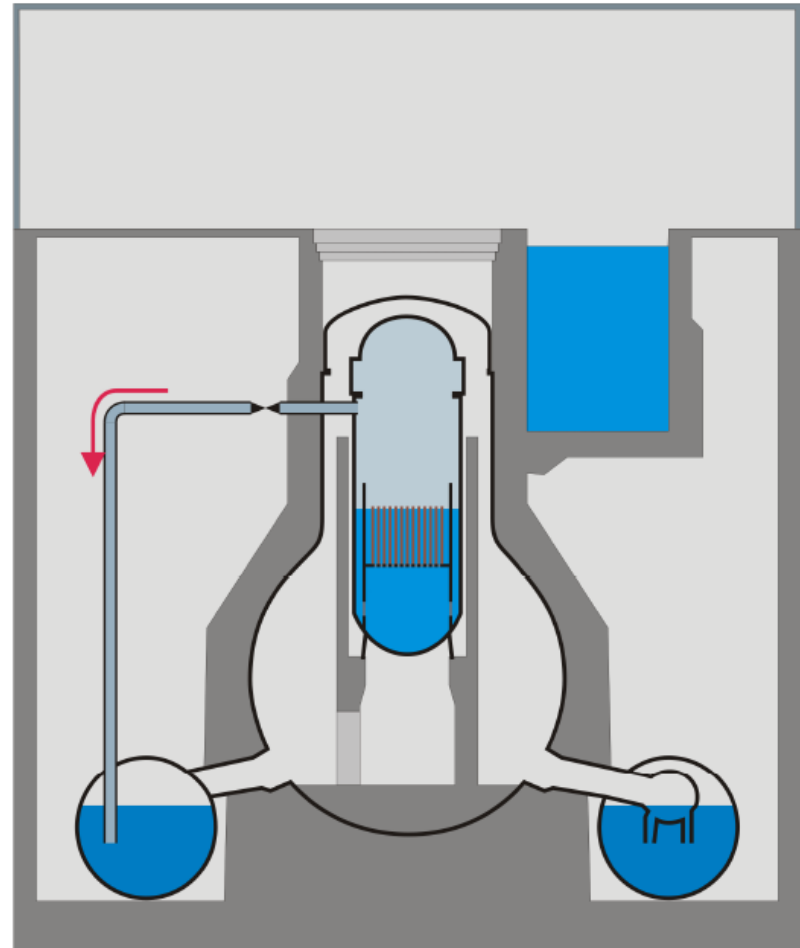
- ▶ Decay heat produces steam in reactor pressure vessel
 - ◆ Pressure rising
- ▶ Opening the steam relieve valves
 - ◆ Discharge steam into the wet-well
- ▶ Decreasing of the liquid level in the reactor pressure vessel

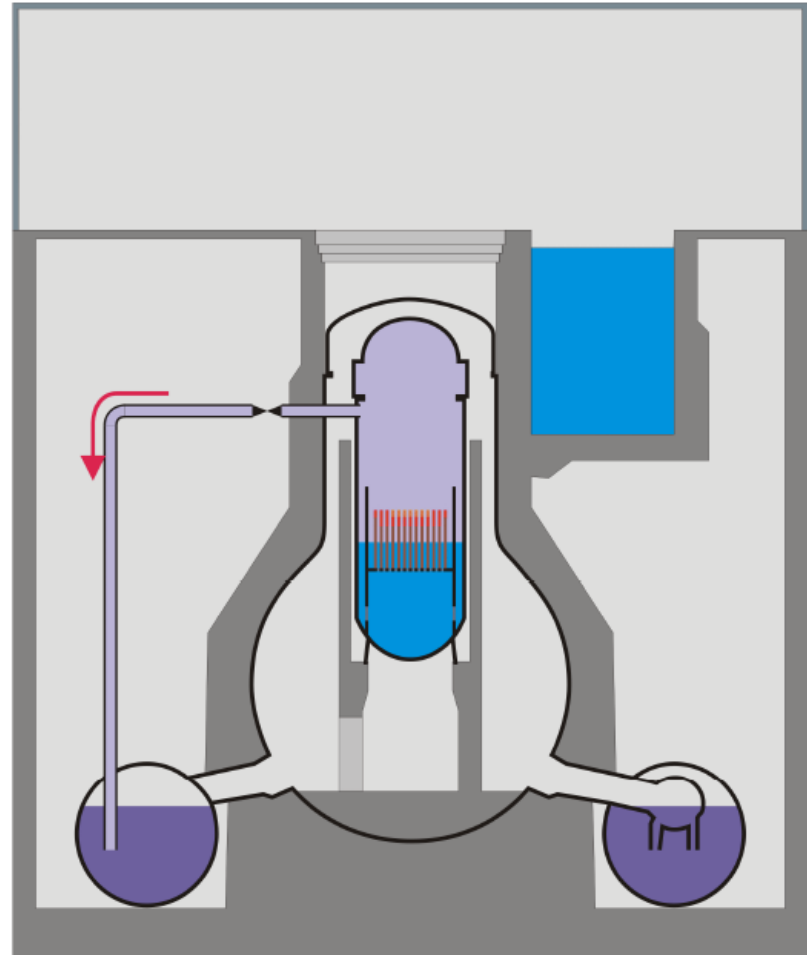
- ▶ Measured, and here referenced liquid level is the collapsed level. The swell level is higher due to the steam bubbles in the liquid
- ▶ ~50% of the core exposed
 - ◆ Cladding temperatures rise, but still no significant core damage
- ▶ ~2/3 of the core exposed
 - ◆ Cladding temperature exceeds $\sim 900^{\circ}\text{C}$
 - ◆ Ballooning / Breaking of the cladding
 - ◆ Release of fission products from the fuel rod gaps

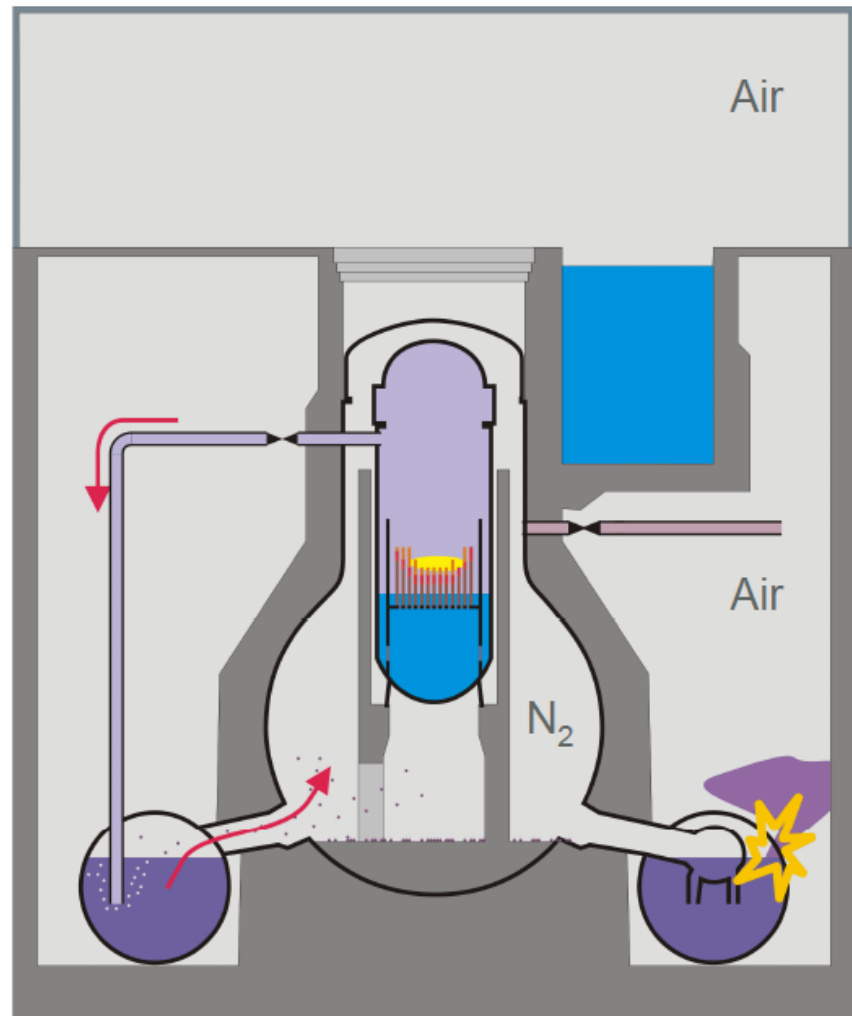
► Unit 2

- ◆ Probably damage of the condensation chamber following a pressure increase in the reactor pressure vessel and containment (highly contaminated water)
- ◆ Uncontrolled release of gas and **fission products** from the containment
- ◆ Temporal evacuation of the plant
- ◆ High local dose rates on the plant site

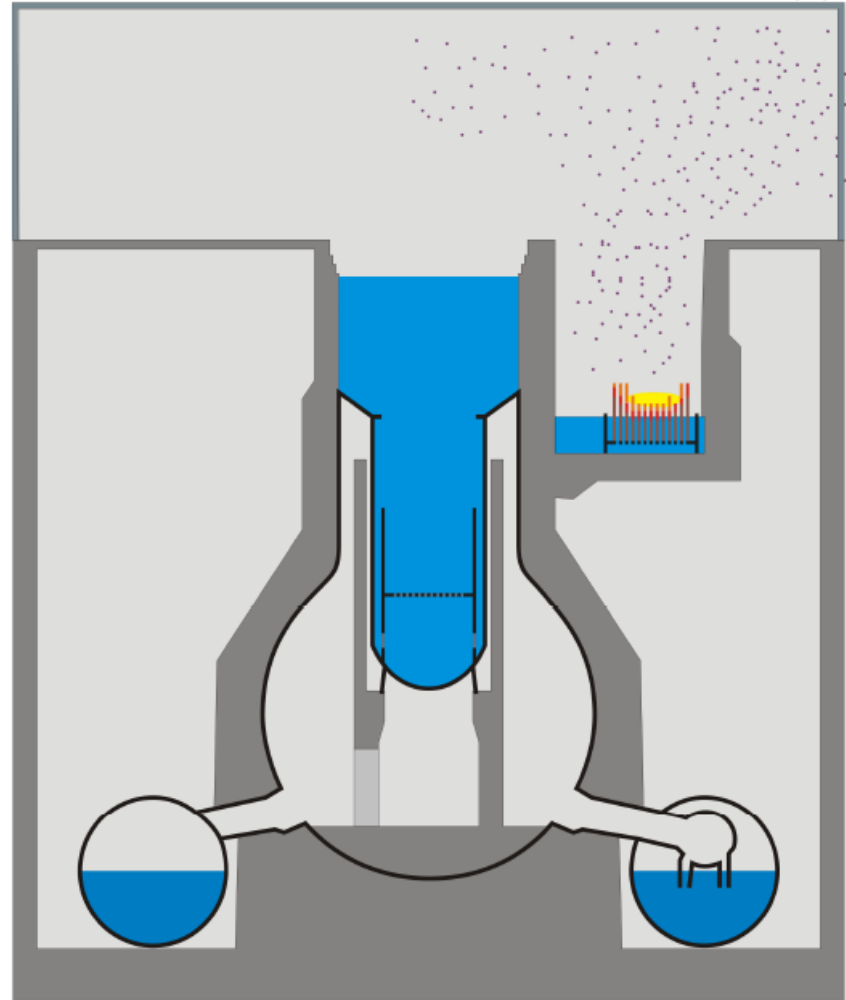
- ▶ Spent fuel stored in pool on reactor service floor
 - ◆ Due to maintenance in Unit 4 entire core stored in fuel pool
 - ◆ Dry-out of the pools
 - Unit 4: in 10 days
 - Unit 1-3,5,6 in few weeks
 - ◆ **Leakage of the pools due to Earthquake?**
- ▶ Consequences
 - ◆ Fuel melt in direct contact to the atmosphere
 - ◆ Nearly no retention of fission products
 - ◆ Large release possible

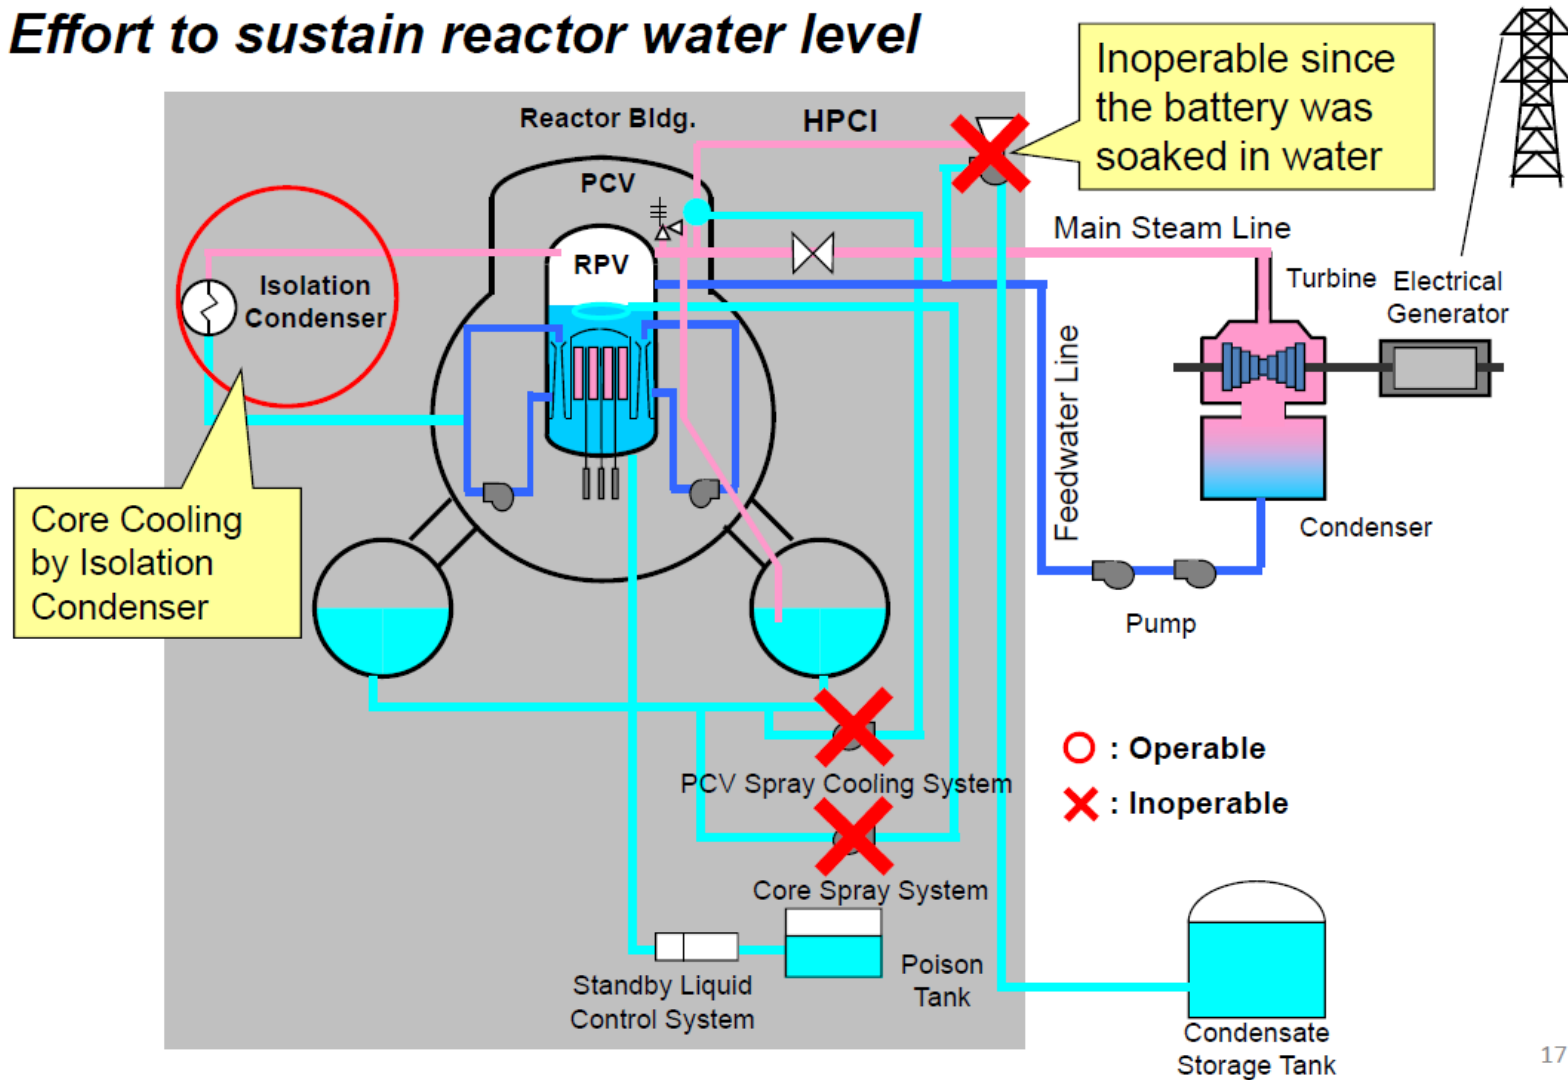
3-7. Major event progression at Unit 1 (1/4)

Effort to sustain reactor water level

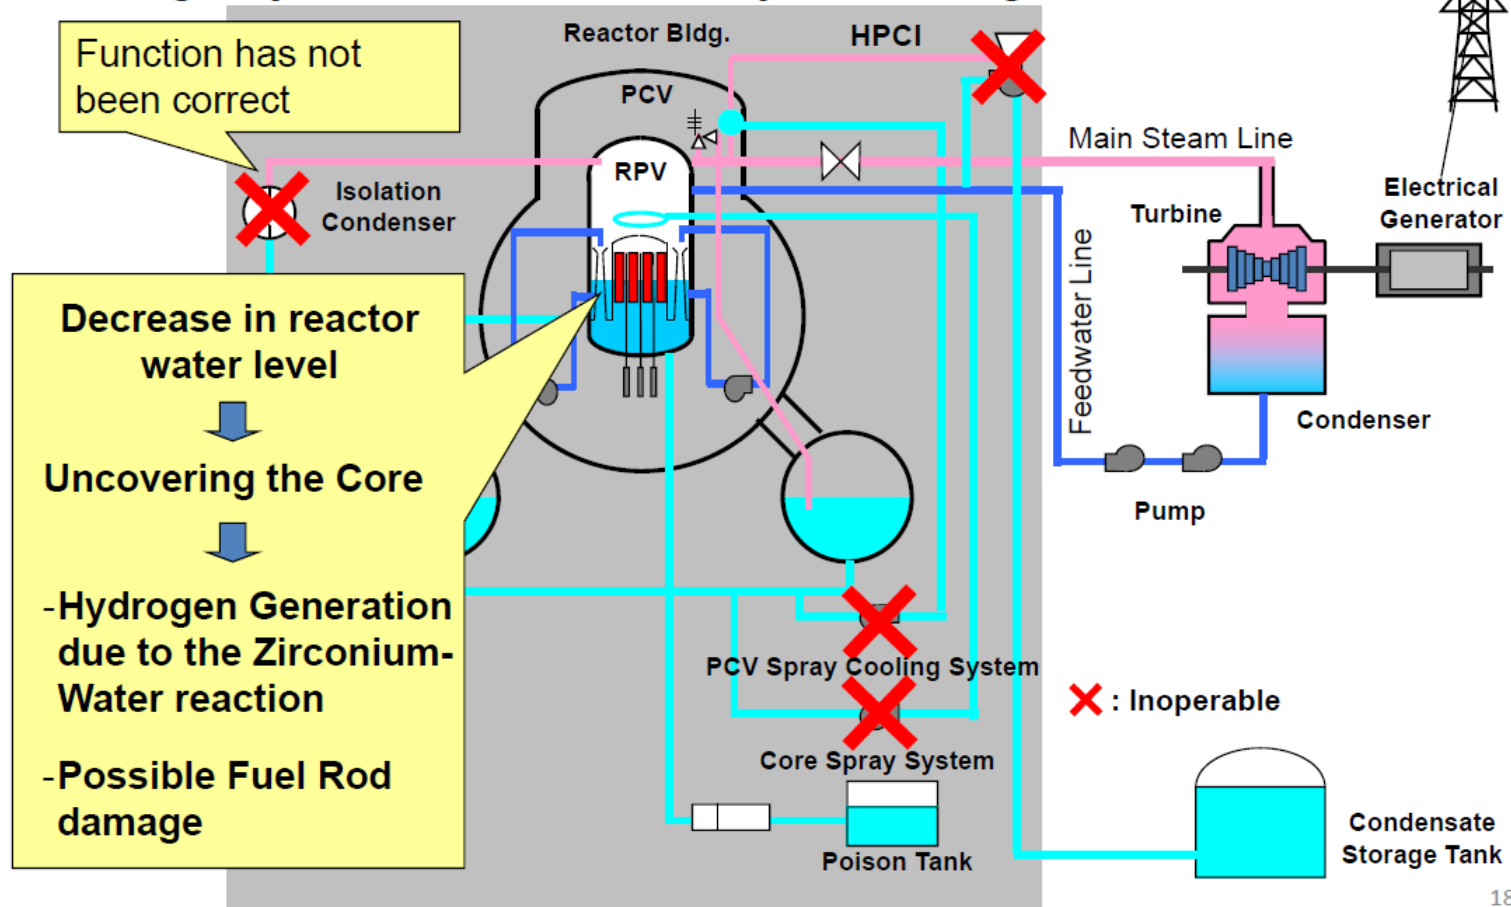
3-7. Major event progression at Unit 1 (2/4)

Decrease in reactor water level due to loss of cooling capability of emergency condenser, followed by uncovering the core

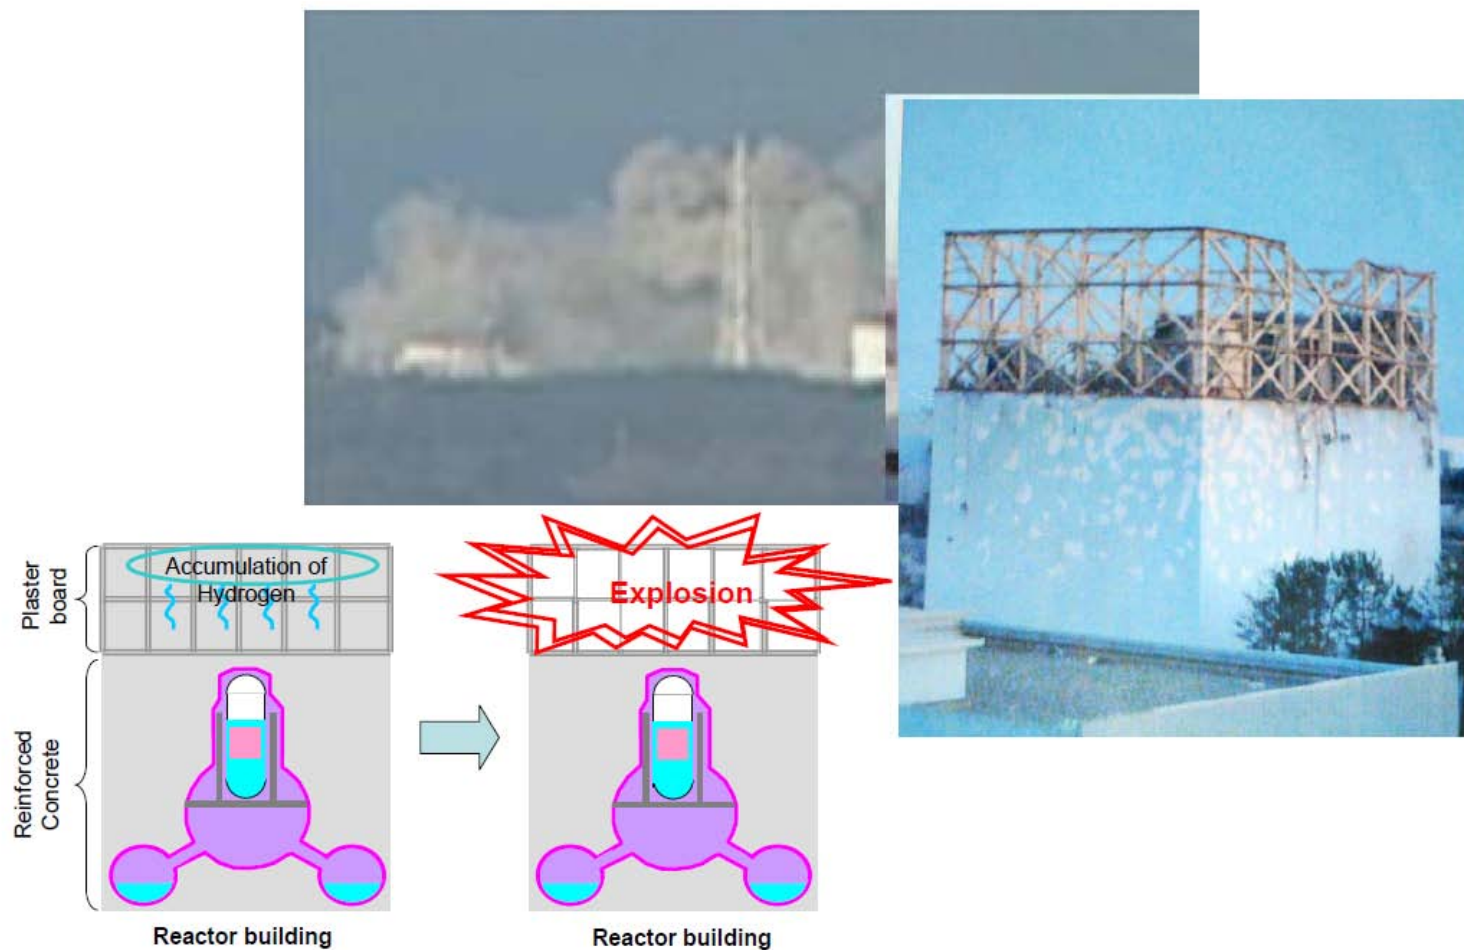
3-7. Major event progression at Unit 1 (3/4)

Hydrogen explosion in the operation floor

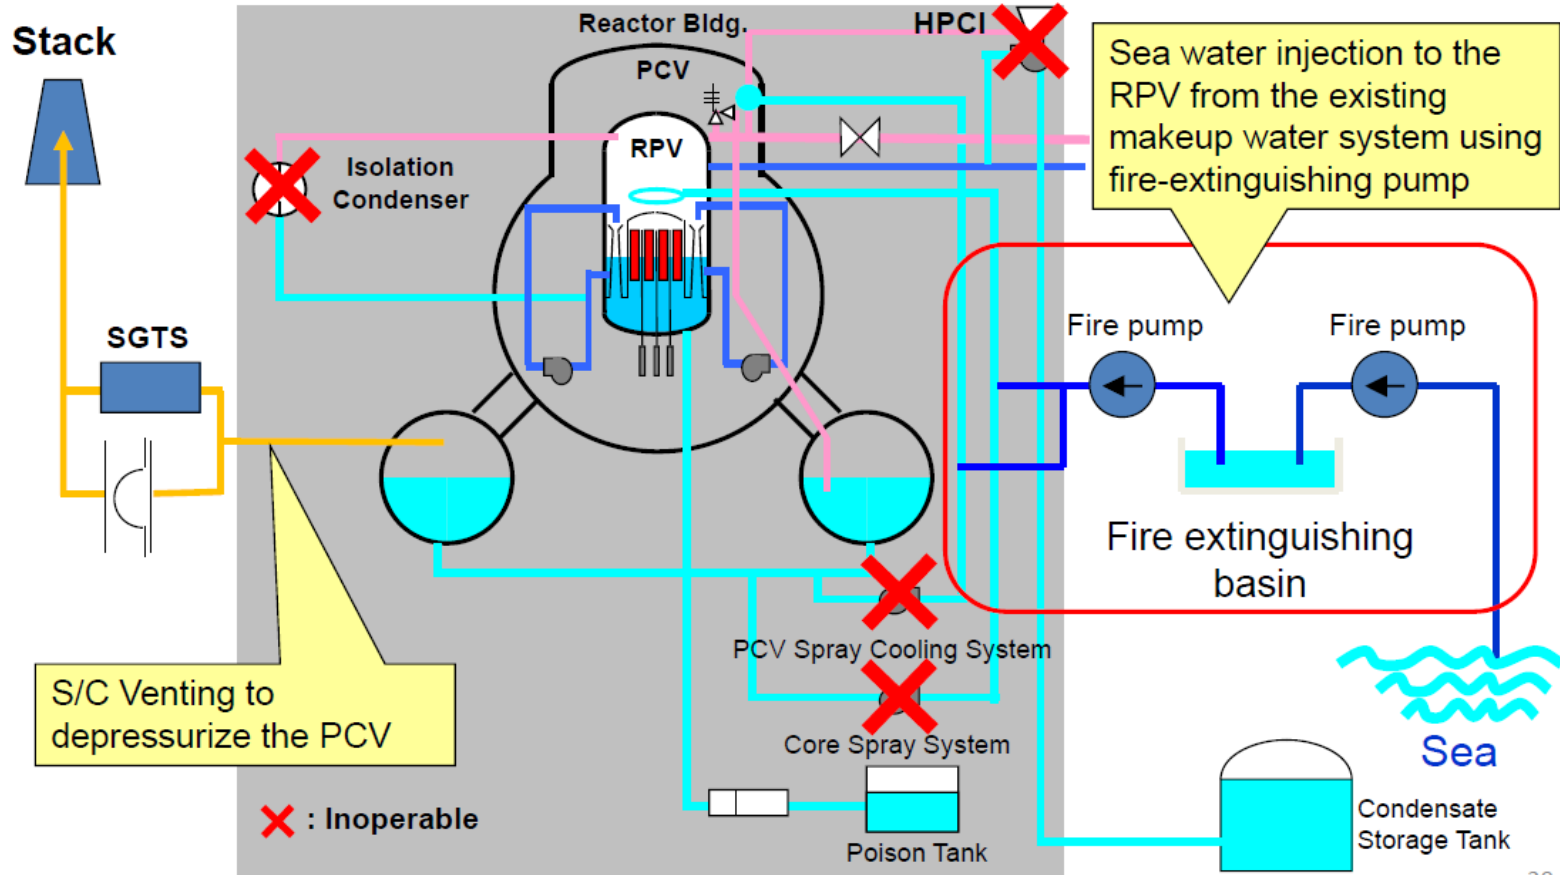
3-7. Major event progression at Unit 1 (4/4)

- **Sea water injection using fire water pump**
- **S/C Venting to depressurize the PCV**

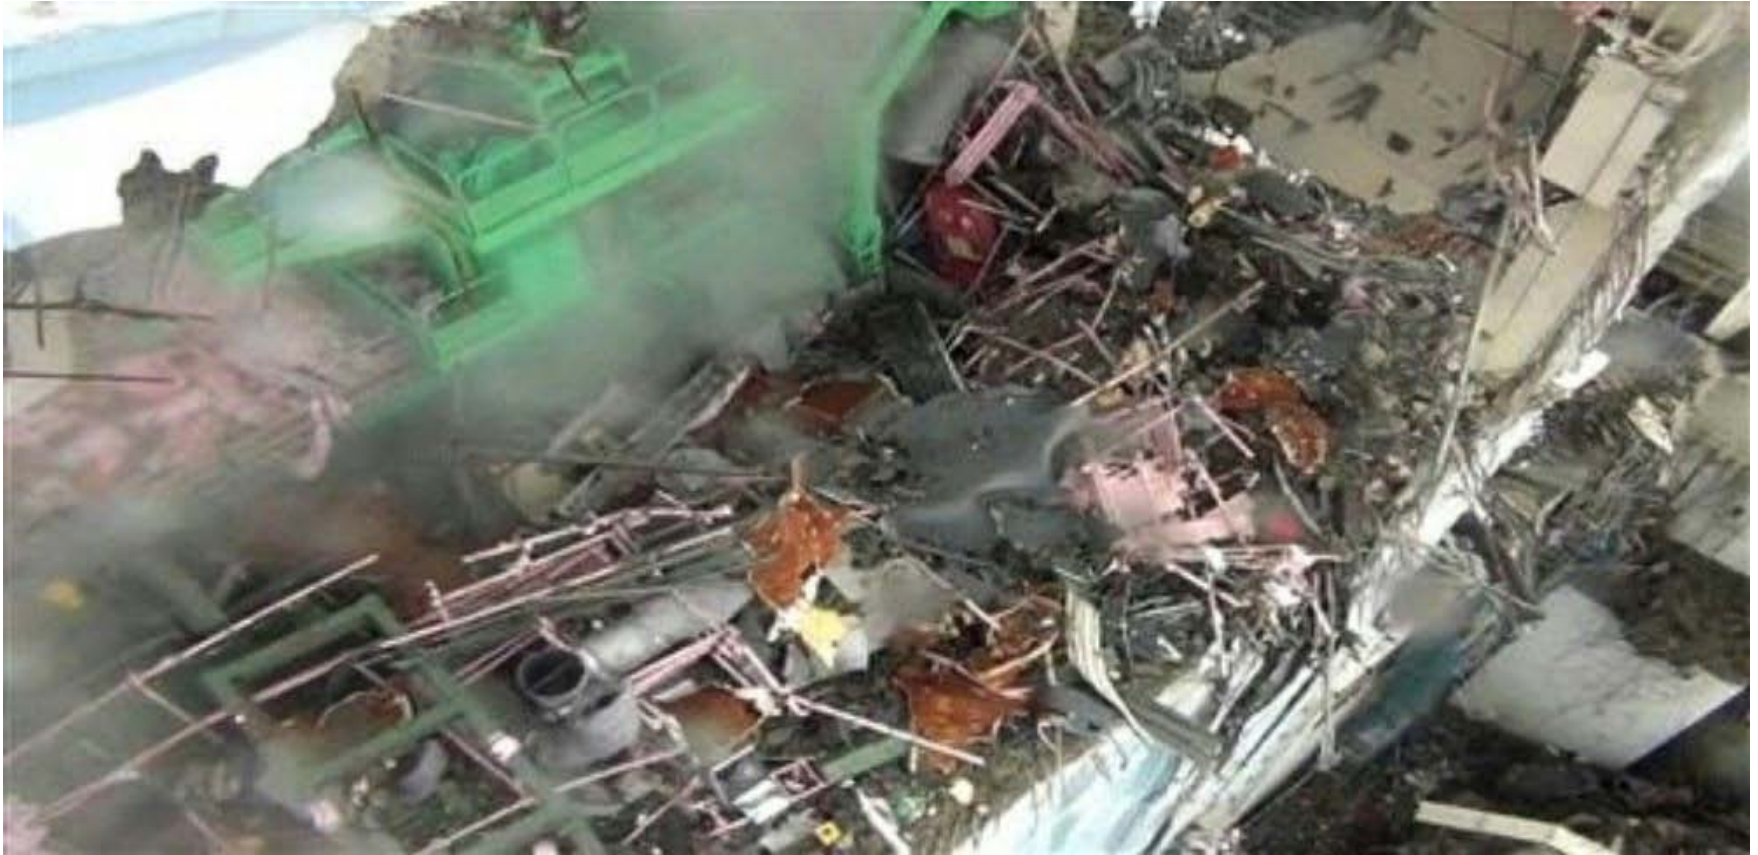
Reactor 4

- ▶ Core completely in the spent fuel pool
- ▶ Reactor service floor damaged
- ▶ Status of the water level in the spent fuel pool unknown
- ▶ Cooling of the spent fuel pool difficult
- ▶ Preparation for reconnection to the external grid

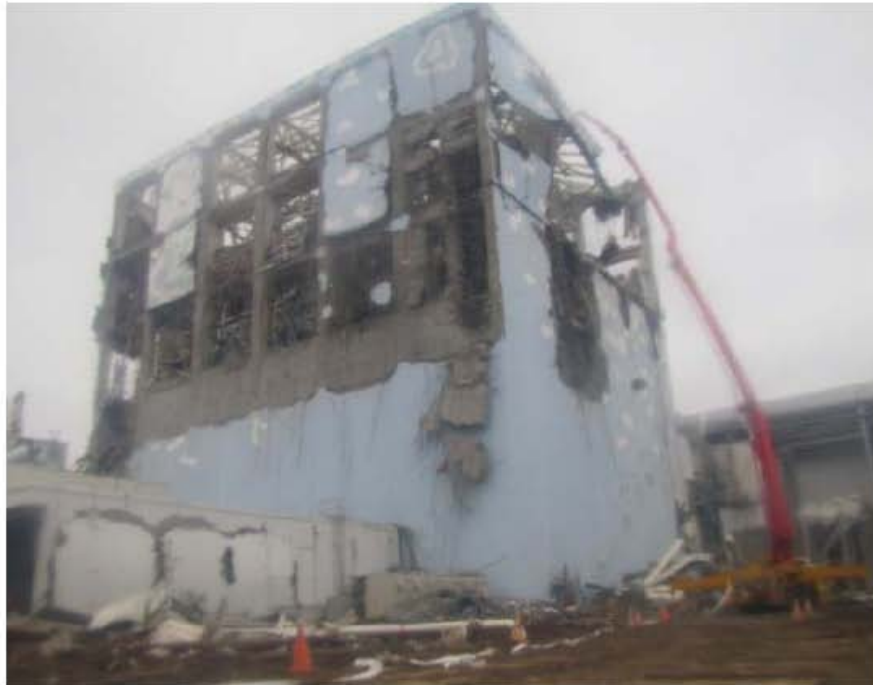
Report concerning incidents at spent fuel pools in the Fukushima Dai-ichi NPS

Photo: Water spray into the SFP in Unit 4 using concrete pump truck

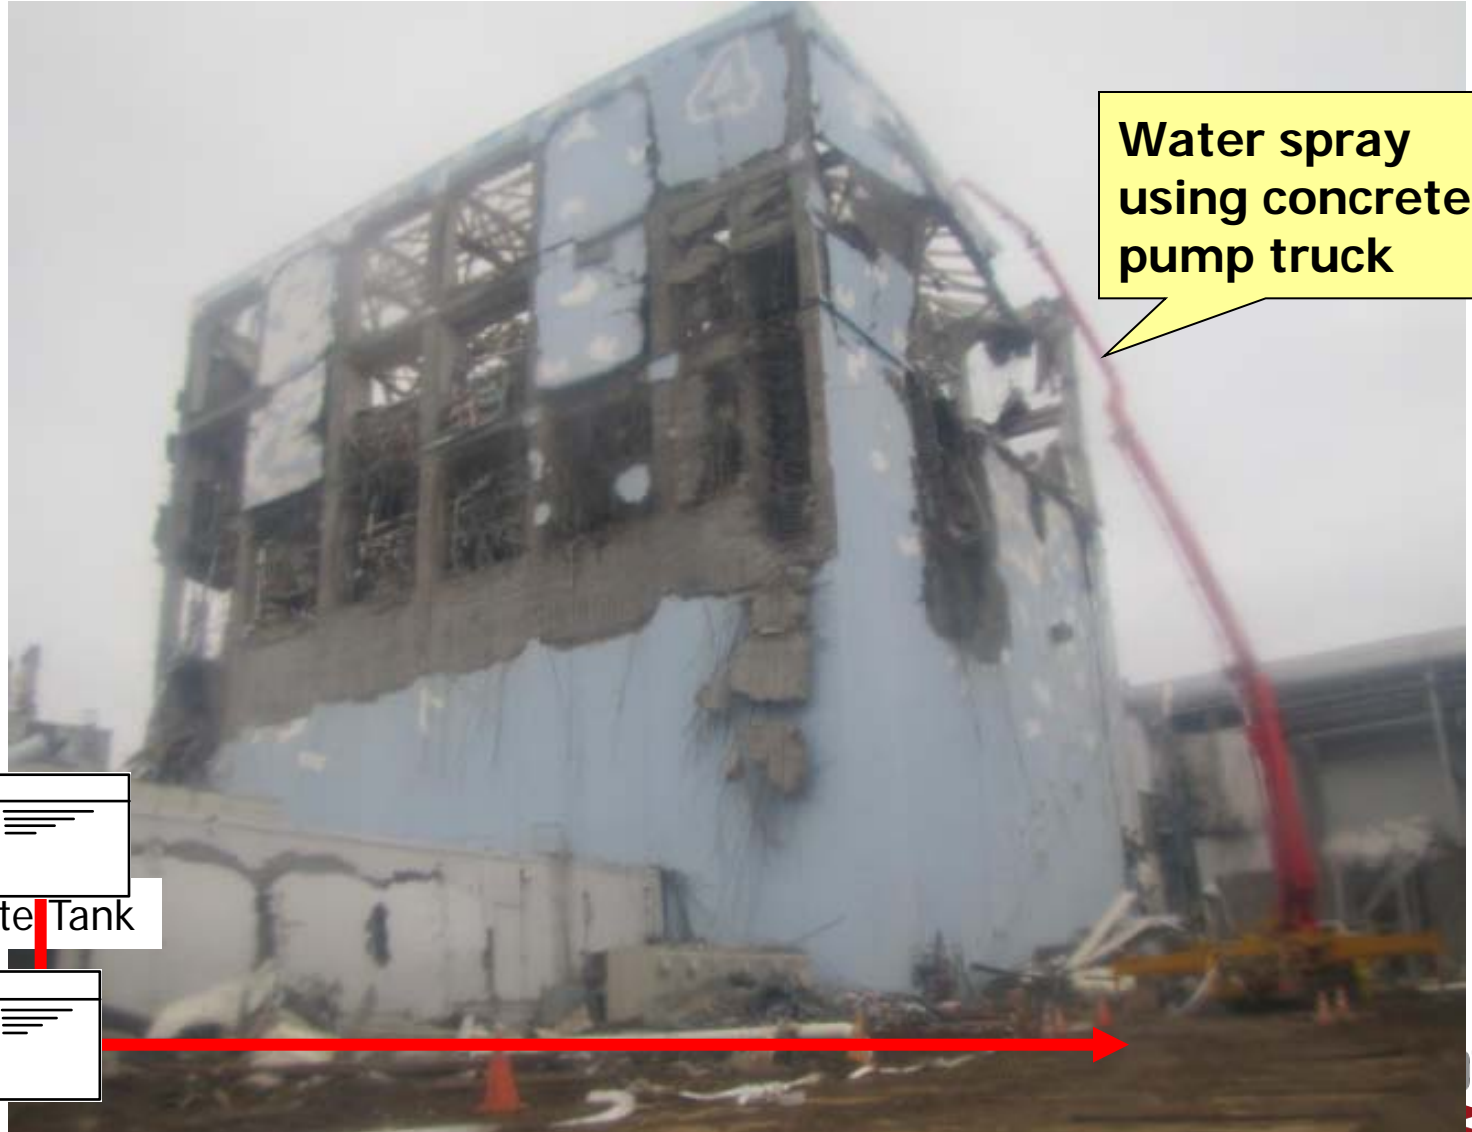
Water spray into the SFP of Unit 4 using concrete pump truck

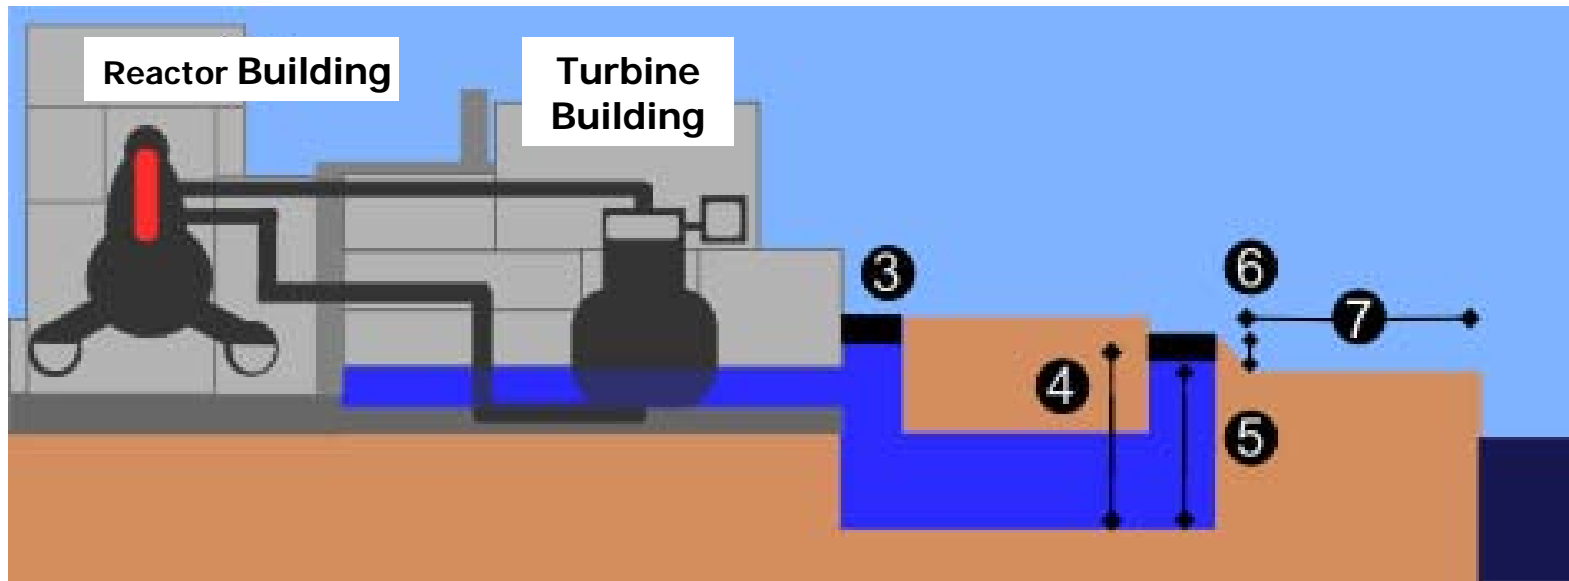
- Highly radioactive water was found in trenches at Units 1, 2 and 3

The Units 2 and 3 trenches were 1 m below the level at which they would overflow into the sea. On the other hand, the unit 1 trench was 10 cm from overflowing. (As of March. 30th)

Side view of the Fukushima trenches and tunnels (*Source: Wikipedia*)

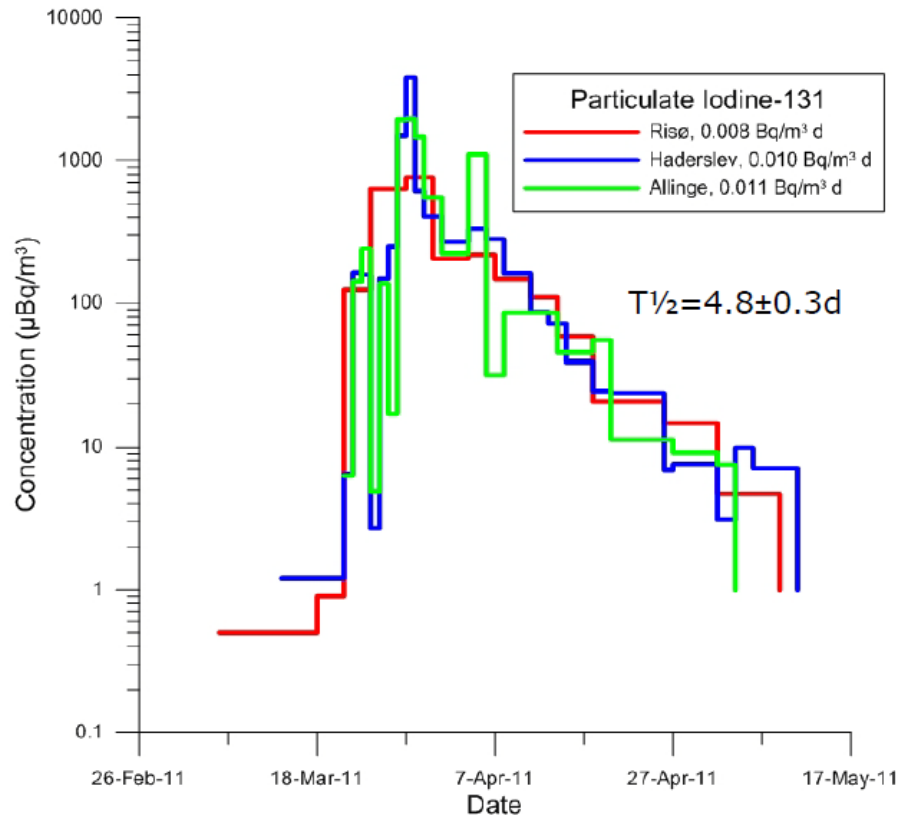
Iodine-131 in Air in Denmark

- Samples based on collection of particles in air by filtration
- Thus gaseous fraction of iodine not collected
- Other labs in Europe using filters and charcoal cartridges for air sampling found two to ten times more gaseous than particulate iodine
- Time-integrated concentrations of ^{131}I in air at three Danish locations range from 0.008 to 0.011 $\text{Bq/m}^3 \text{ d}$.
